Sources of Enterococci to the Park View Canal in Miami Beach

Presentation given by Helena Solo-Gabriele, Ph.D., P.E. Professor, University of Miami January, 2023

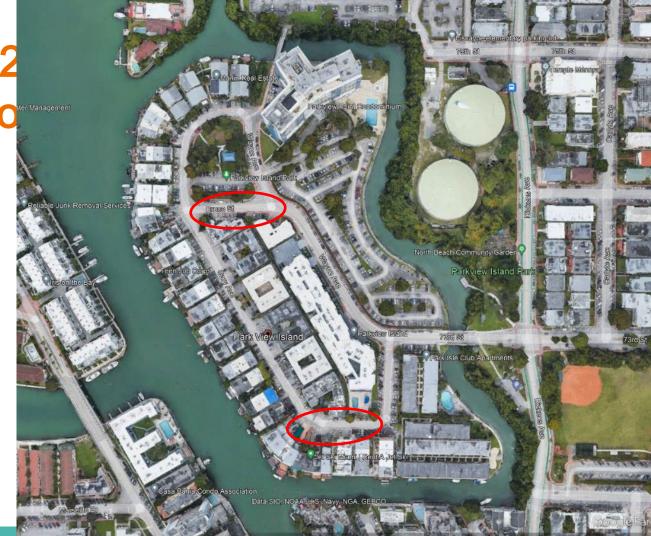
Bruce and Wayne Street Raymond and Gary Ave

January 19, 202 Sewage Overflotter Management

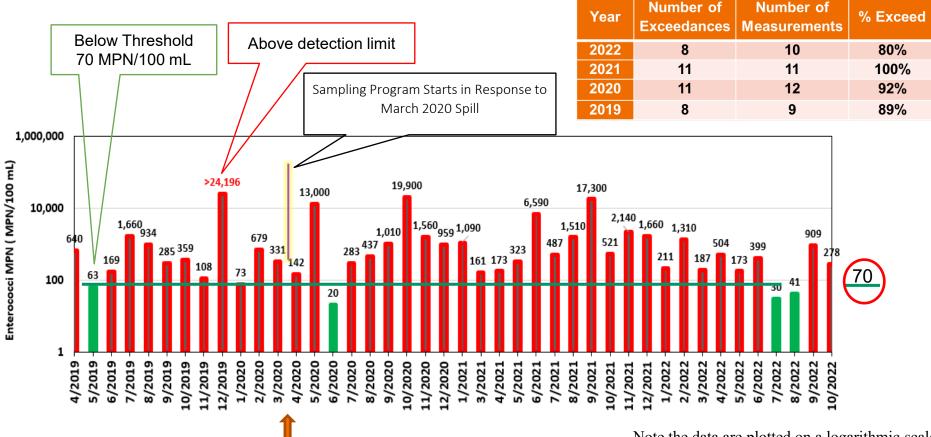
Historic Enterococci Concentrations in PVC Canal

Sewage Spill at Harding & 72 Street

Note the data are plotted on a logarithmic scale due to the wide range of measurements.

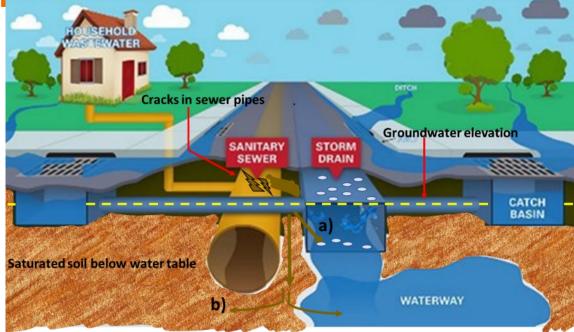
Close Proximity of Stormwater Conveyance Syste Sanitary Sewer Makes it Vulnerable to Possible Contamination

Possible but not proven underground connection

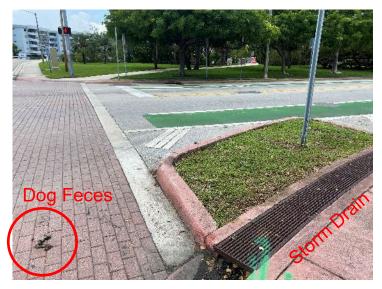
Visible Feces

Animal feeding stations that attract feral animals such as roosters, iguanas, racoons, rats. Dog feces visible.	Remove animal feeding station. Remove feral animals humanely. Continue dog waste removal education program. Designate clean up schedule to address visible feces.
Homeless (4 encampments)	Remove access to areas under bridges. Provide facilities for homeless. Lazarus project may help.
Trash in waterway	Remove trash caught in mangroves. Increase trash removal from streets. Install trash catch systems in storm sewers.
Trash and debris in curbs	More frequent street sweeping.
Trash bins from commercial establishments leaking liquids	Frequent inspections and enforcement of covered trash bins.
Shaded embankments with natural soils.	Minimize inputs from animals along shore. Improvements to water quality.

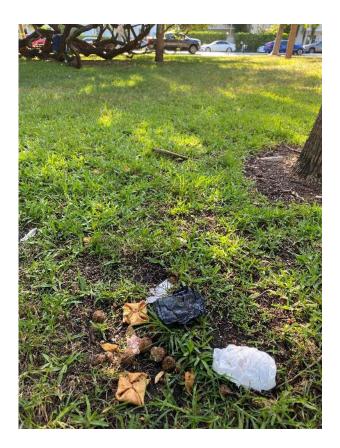
Animal Feeding Station

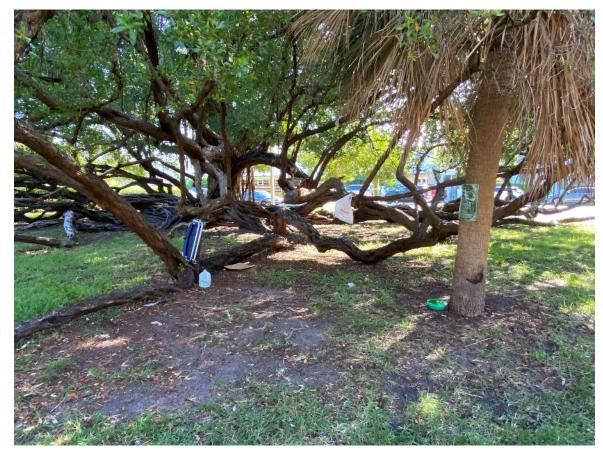
Homeless

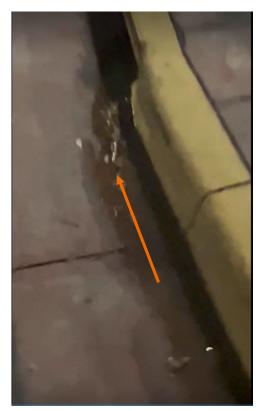
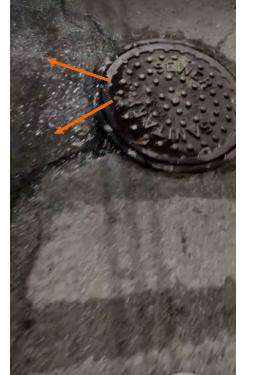
Bruce and Wayne Courtesy of PVI Resident

Sewer Overflow (from Jan. 19, 2023)
