# Assessment of Enterococci in Groundwater and Stormwater at the Miami Beach Park View Canal

March 11, 2025

University of Miami Team: Ayaaz (Johann) Amirali, Cristina Fayad Martinez, Aaroqi Talati, Diego Lopez Oranday, Larissa Montas, Isabela Puente, Rivka Reiner, Matthew Roca, **Helena Solo-Gabriele**

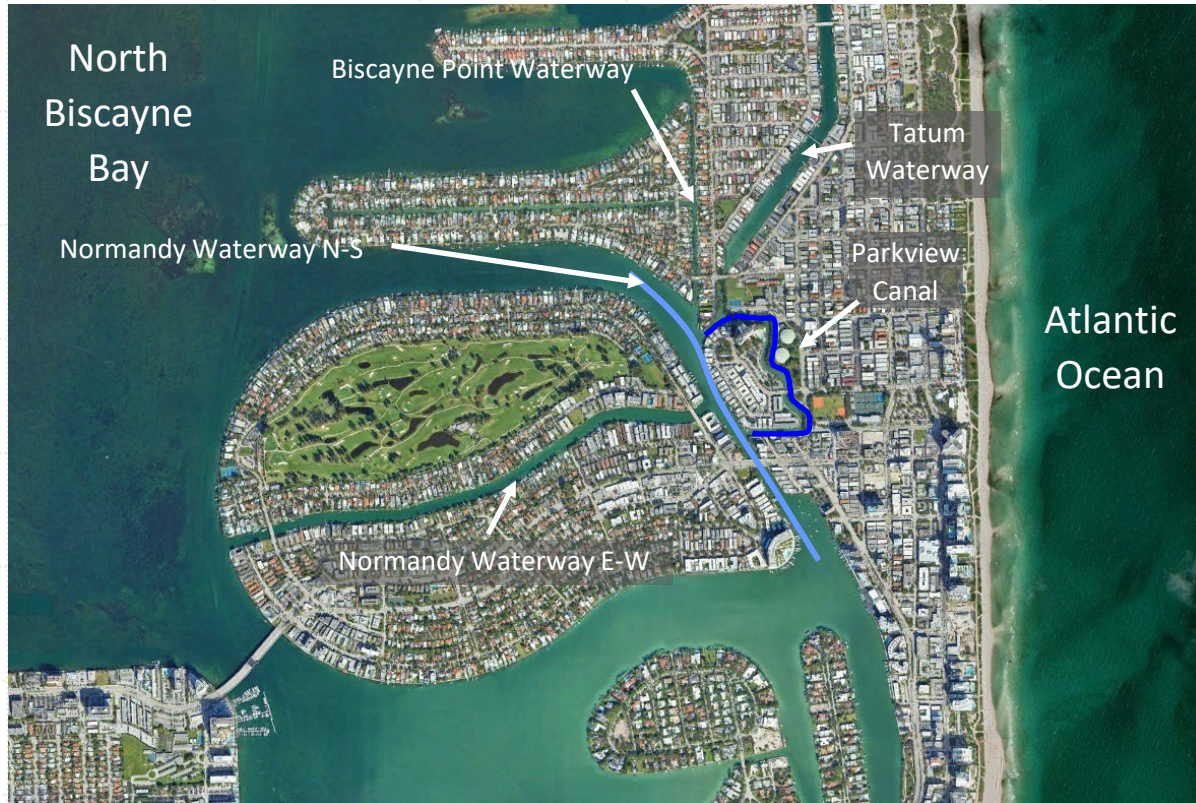
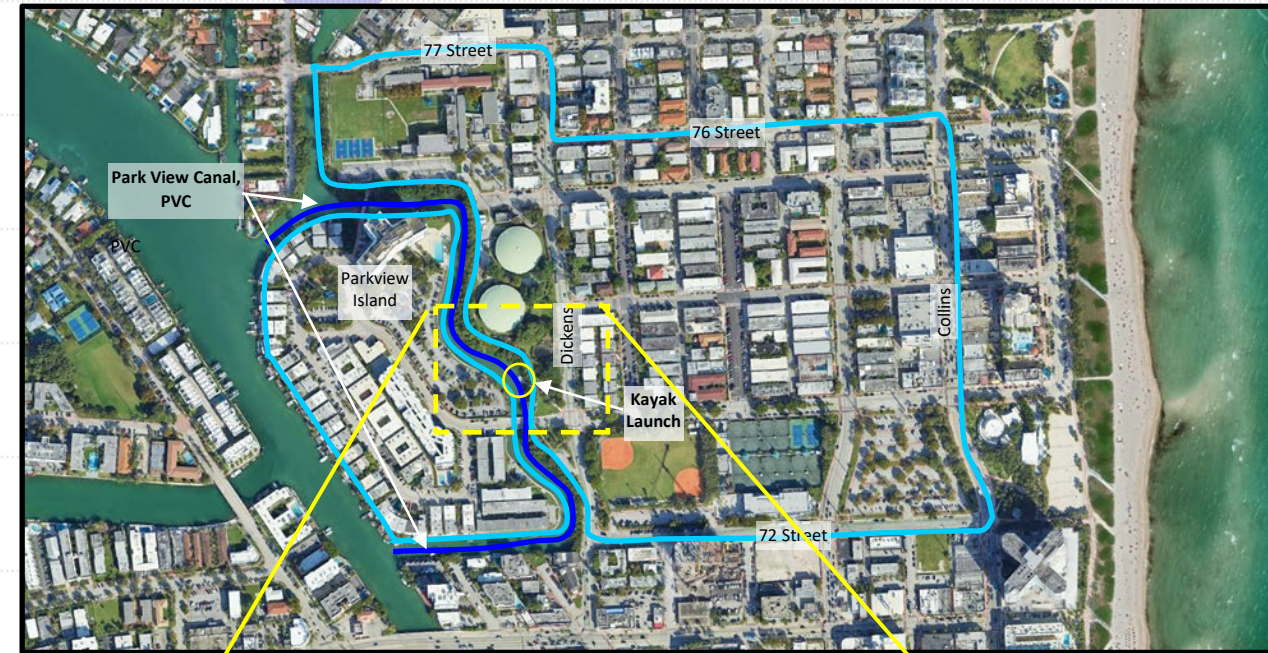
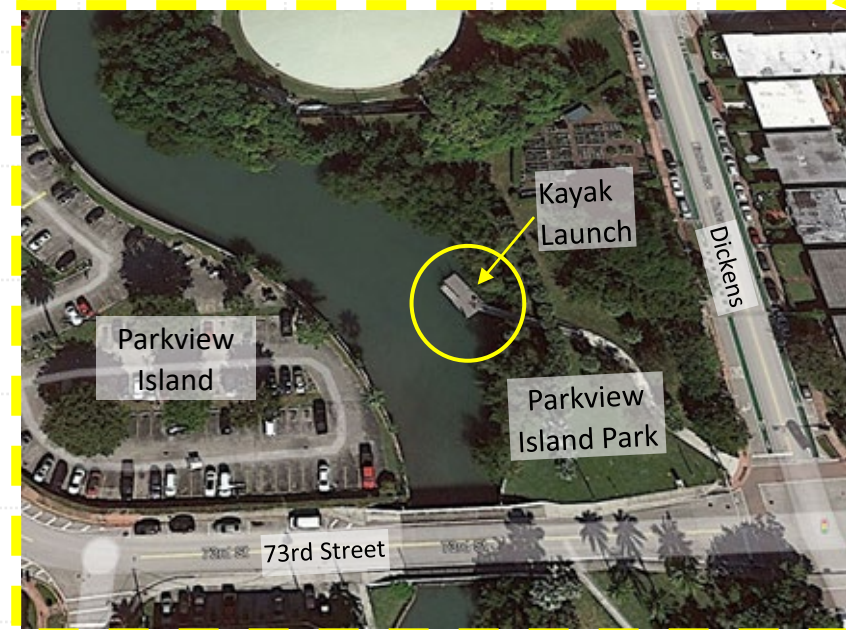
# PVC has Limited Natural Flushing within an Impaired Bay

81.3-acre catchment  
No first flush treatment

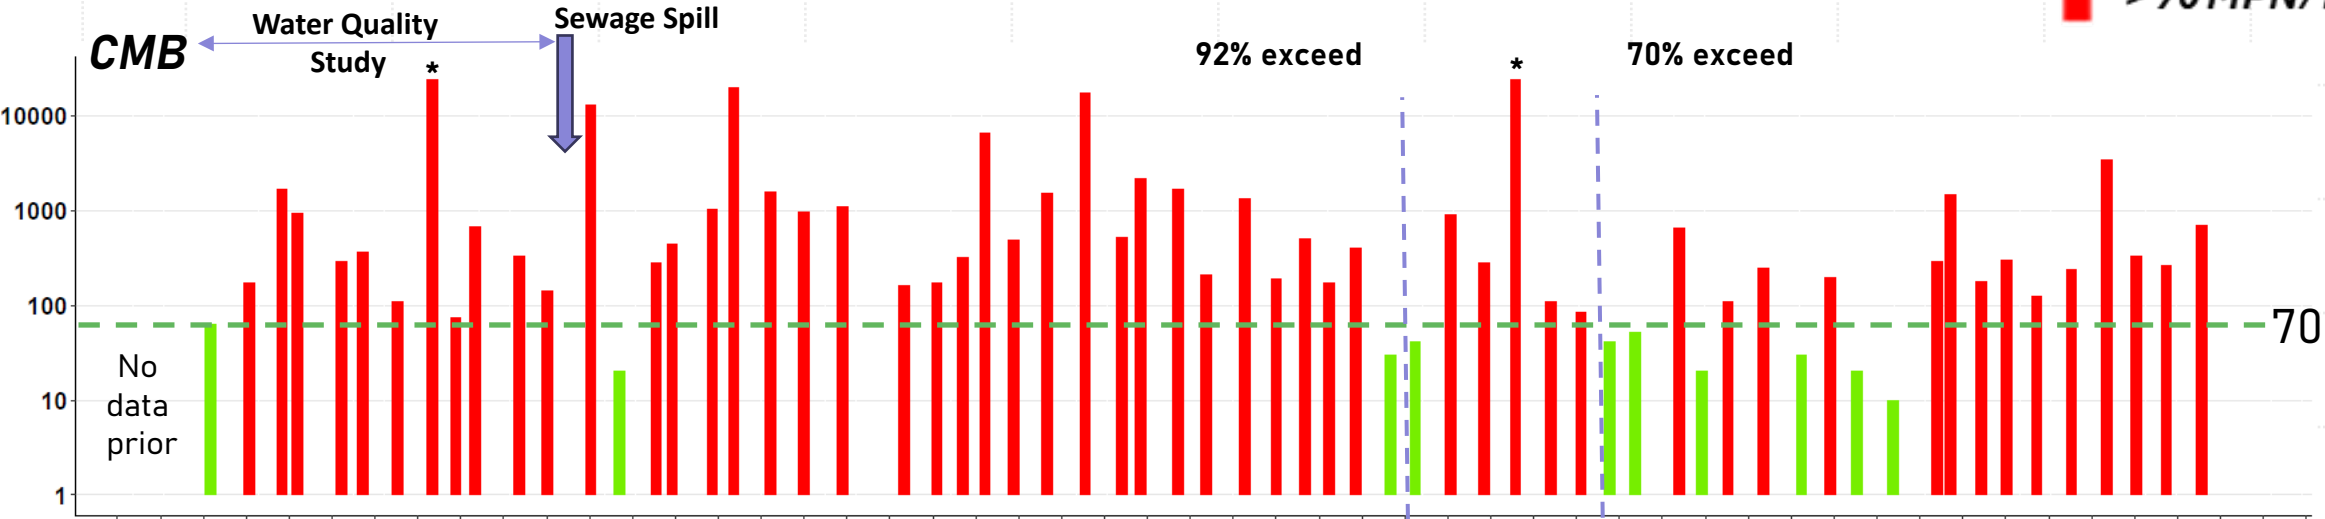
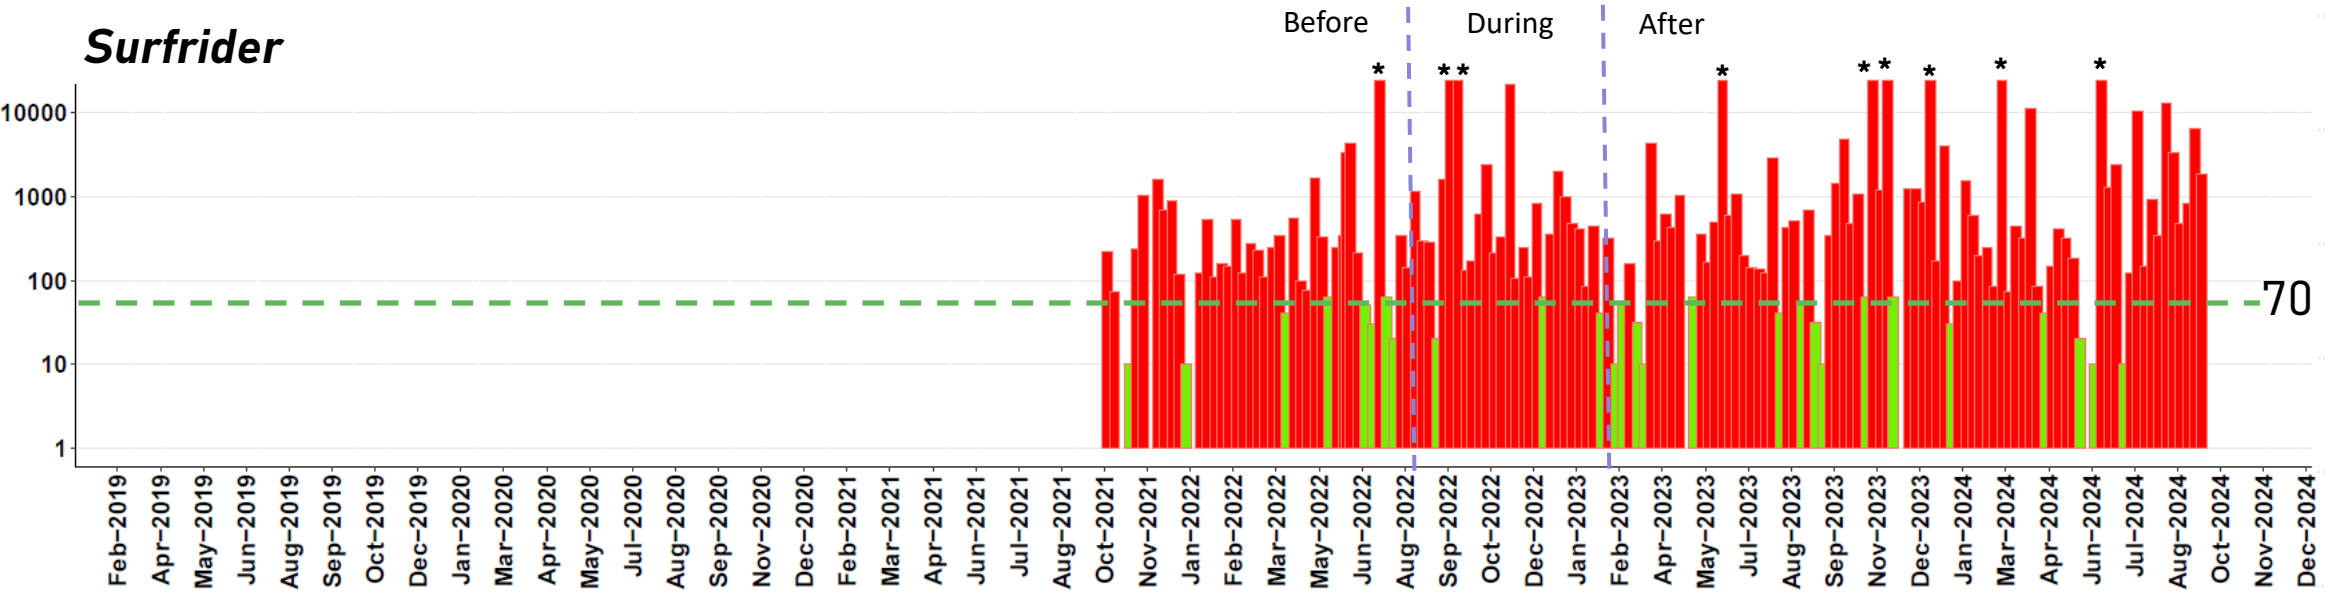
# Enterococci elevated in PVC

< 70 MPN/100ml

> 70 MPN/100ml

Improved but still elevated

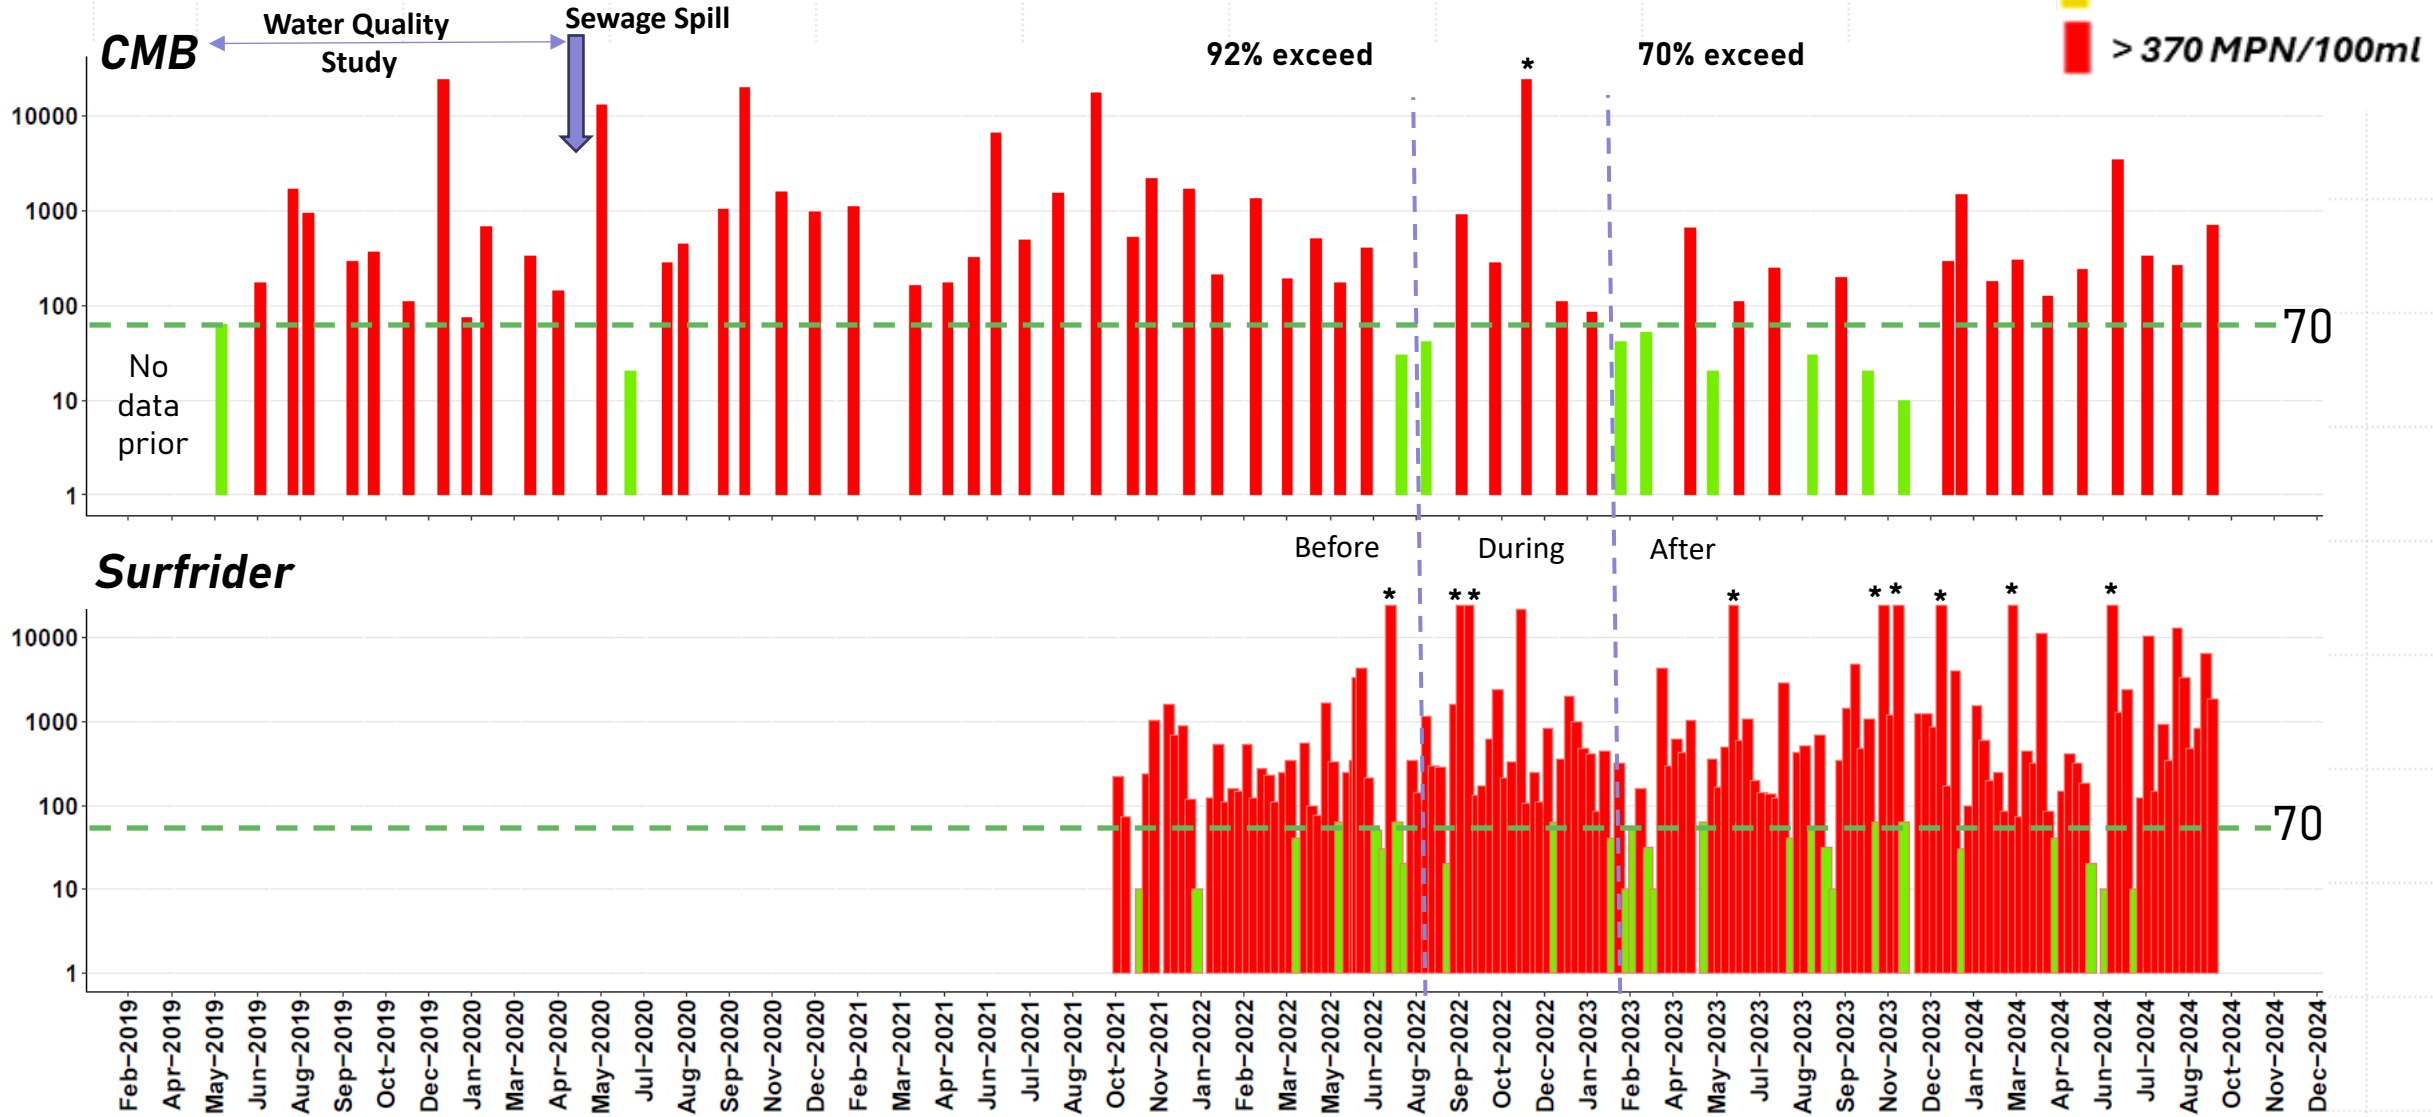
# Enterococci elevated in PVC

Improved but still elevated

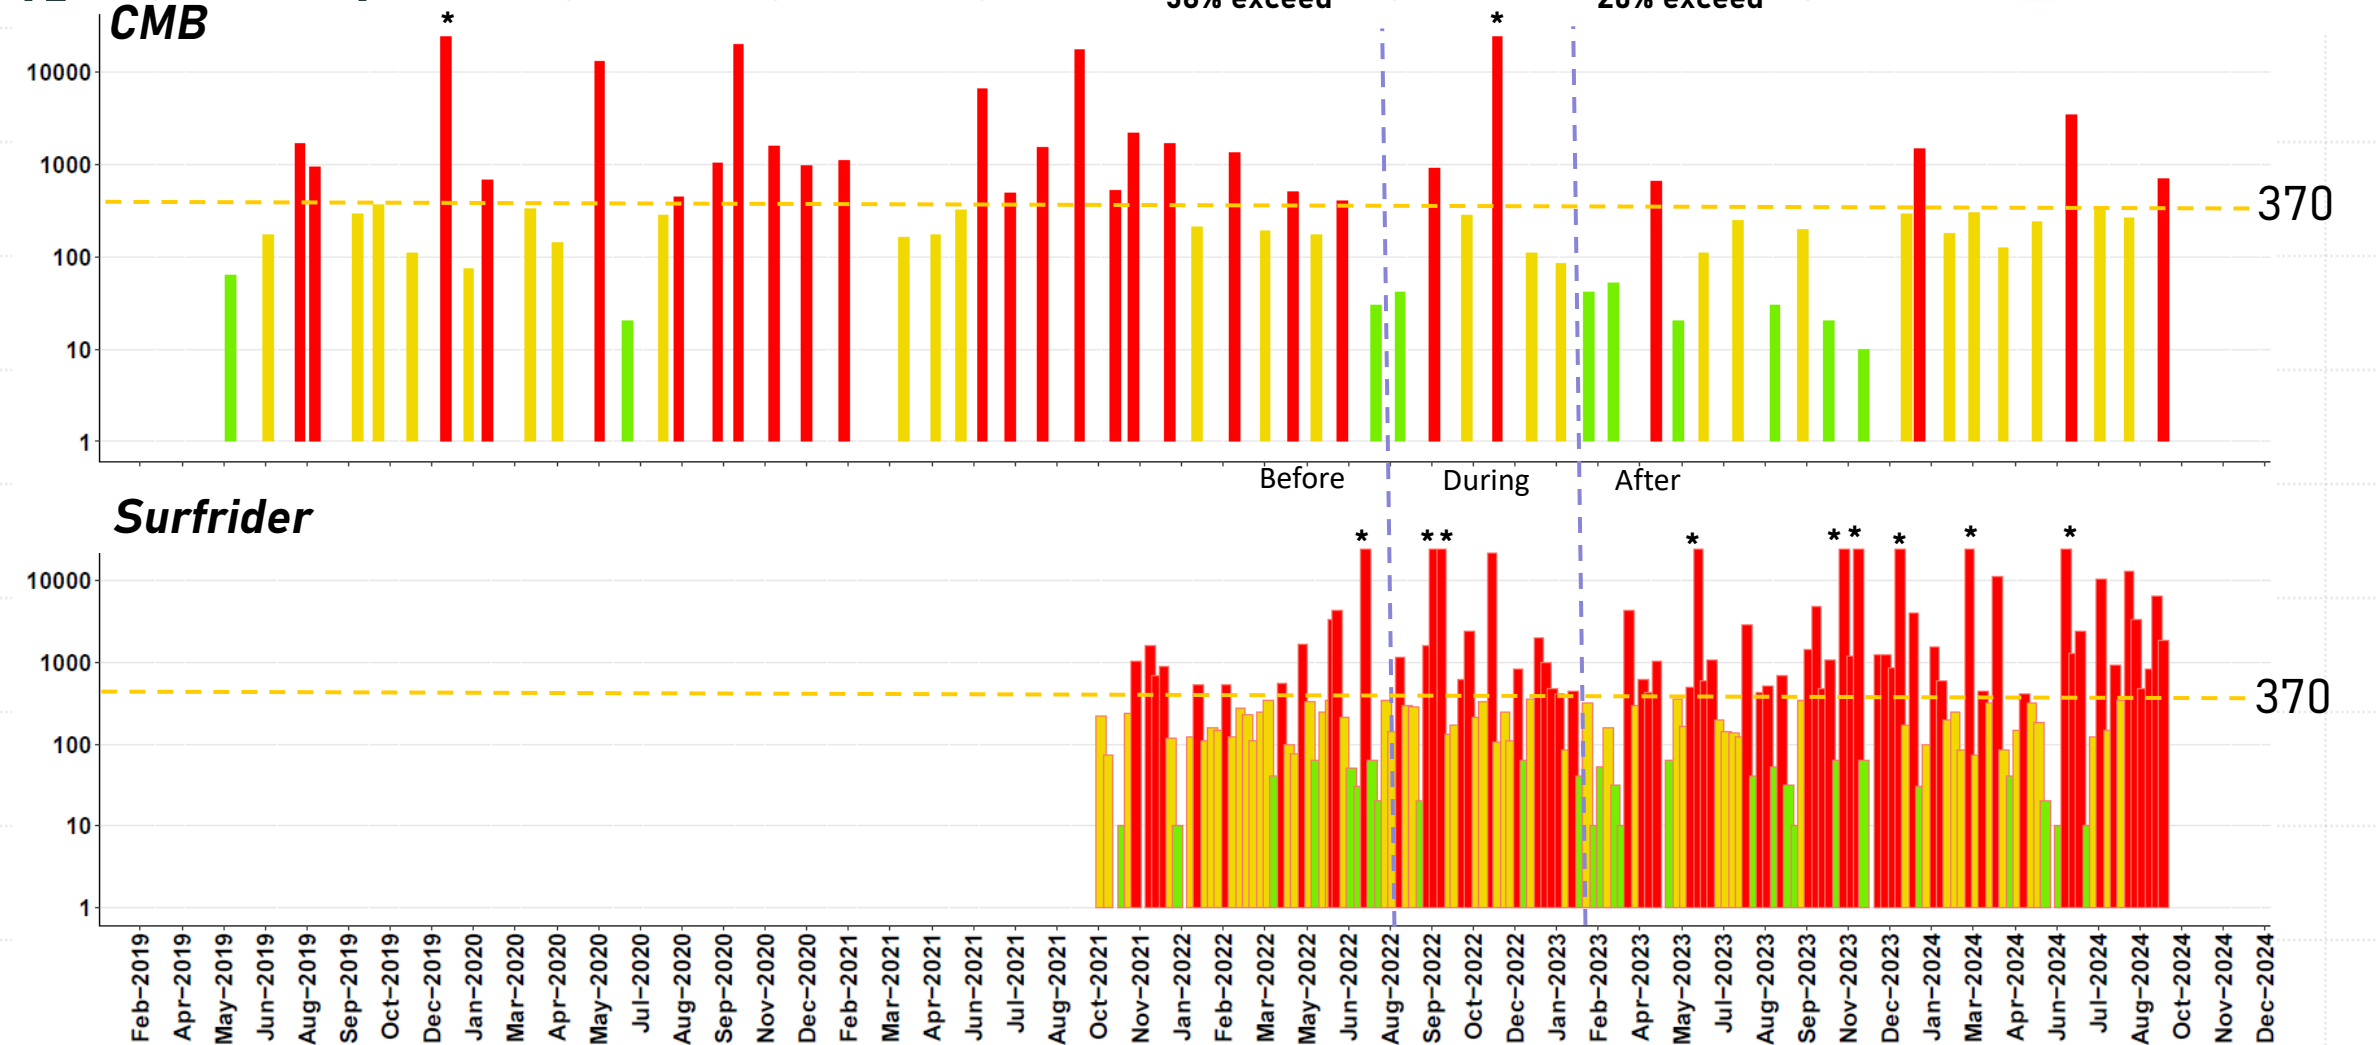
# Considering Kayaking Guidelines

Still elevated above 370, but closer for intended use

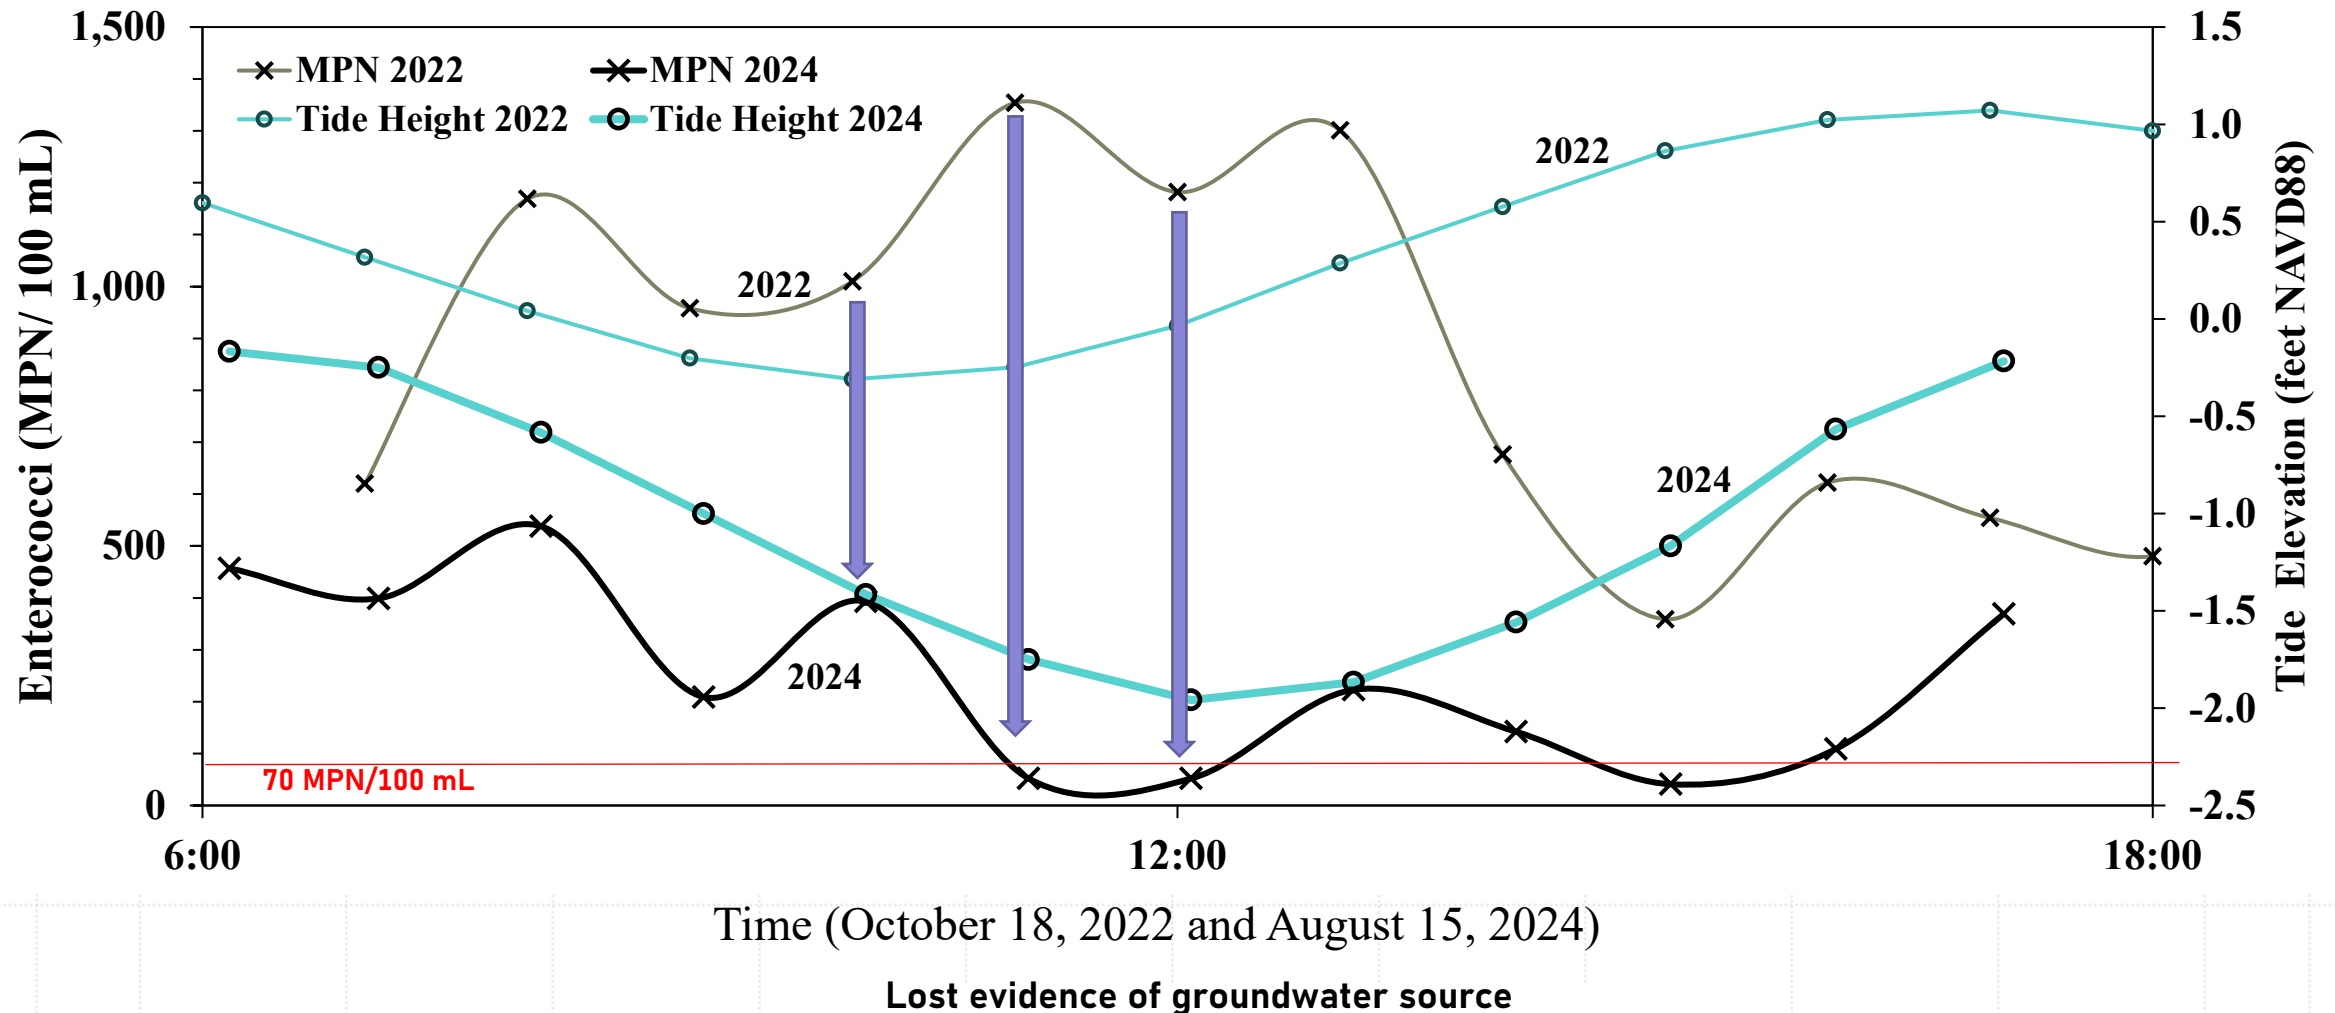
# Enterococci values dropped significantly b/w storm events, suggesting ARVs and pipe lining have had a positive impact

- Enterococci levels lower between storm events (lost earlier signal of possible sewer leaks).
- Sanitary sewer pipe-lining and repair of air release valves appears to have improved water quality between storms
- **Main water type contributing to enterococci in the PVC is stormwater**
- Source to stormwater comes from birds, humans, and dogs from street runoff
- Additional load from birds within the PVC
- BBE outfall contributes enterococci to the PVC

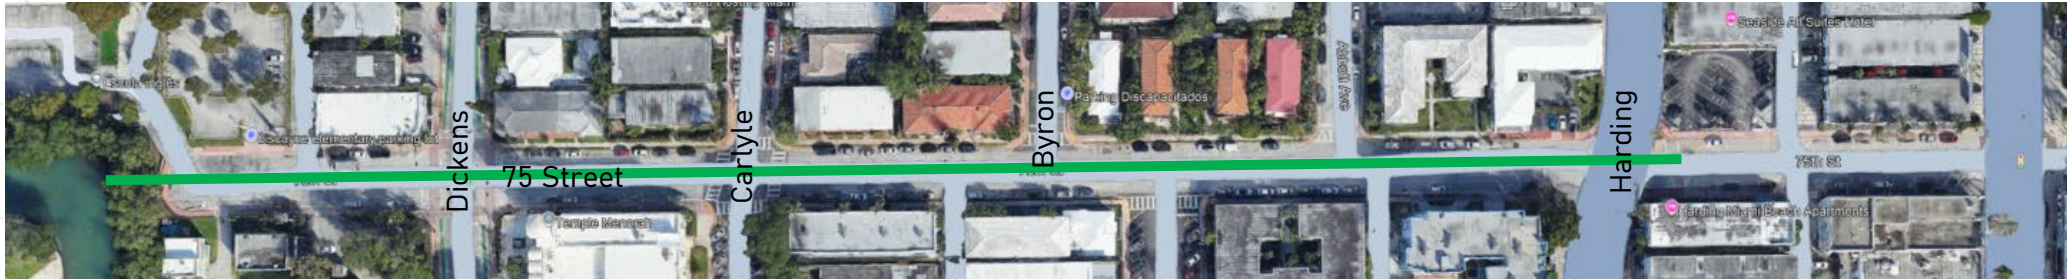
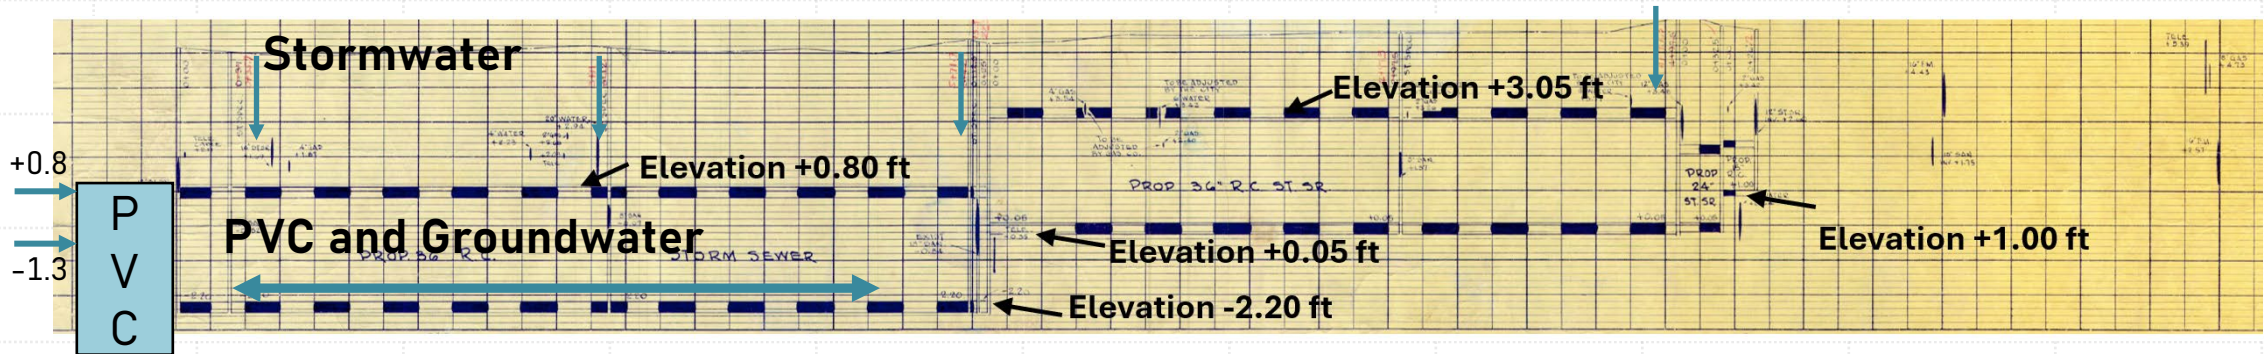
Section Drawings

# Prior UMiami study in 2022→ Main water type is from stormwater conveyance system

Water in stormwater conveyance system mix of stormwater, groundwater, and PVC water

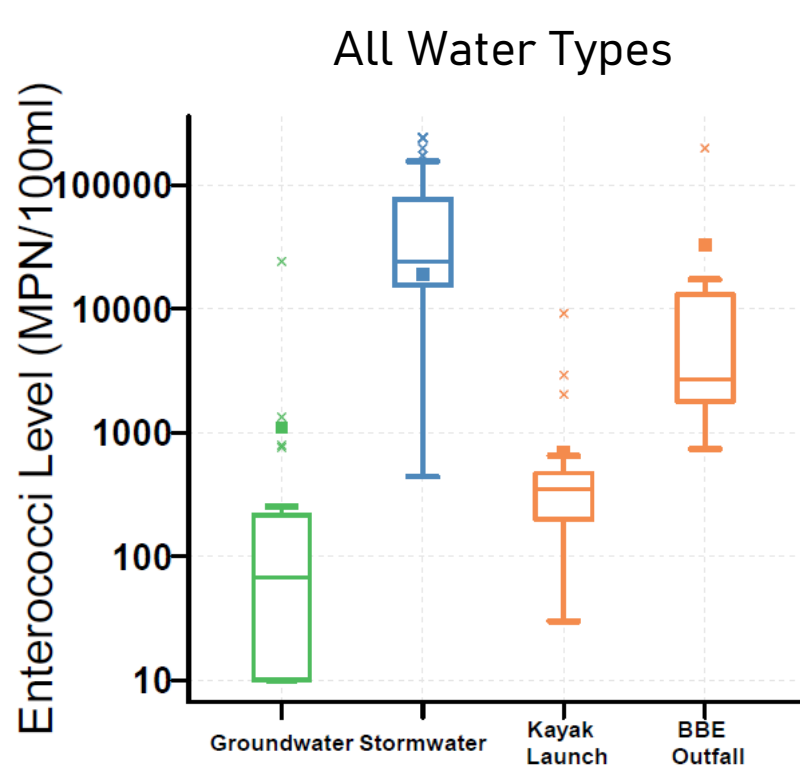
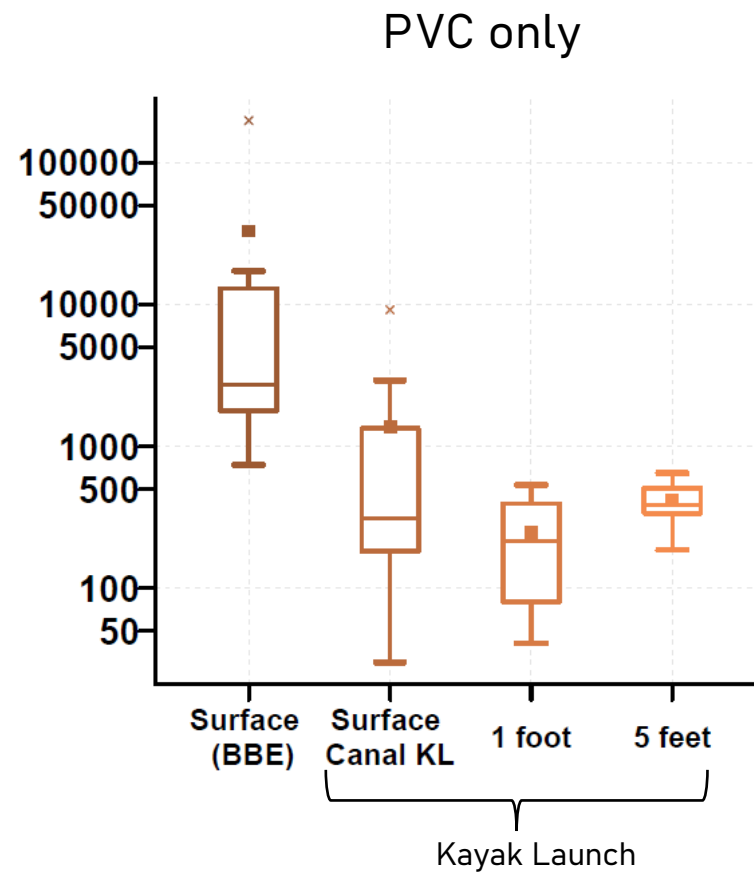
# Charts below compare the different samples by water type and depth within PVC

UMiami Samples (Enterococci only)

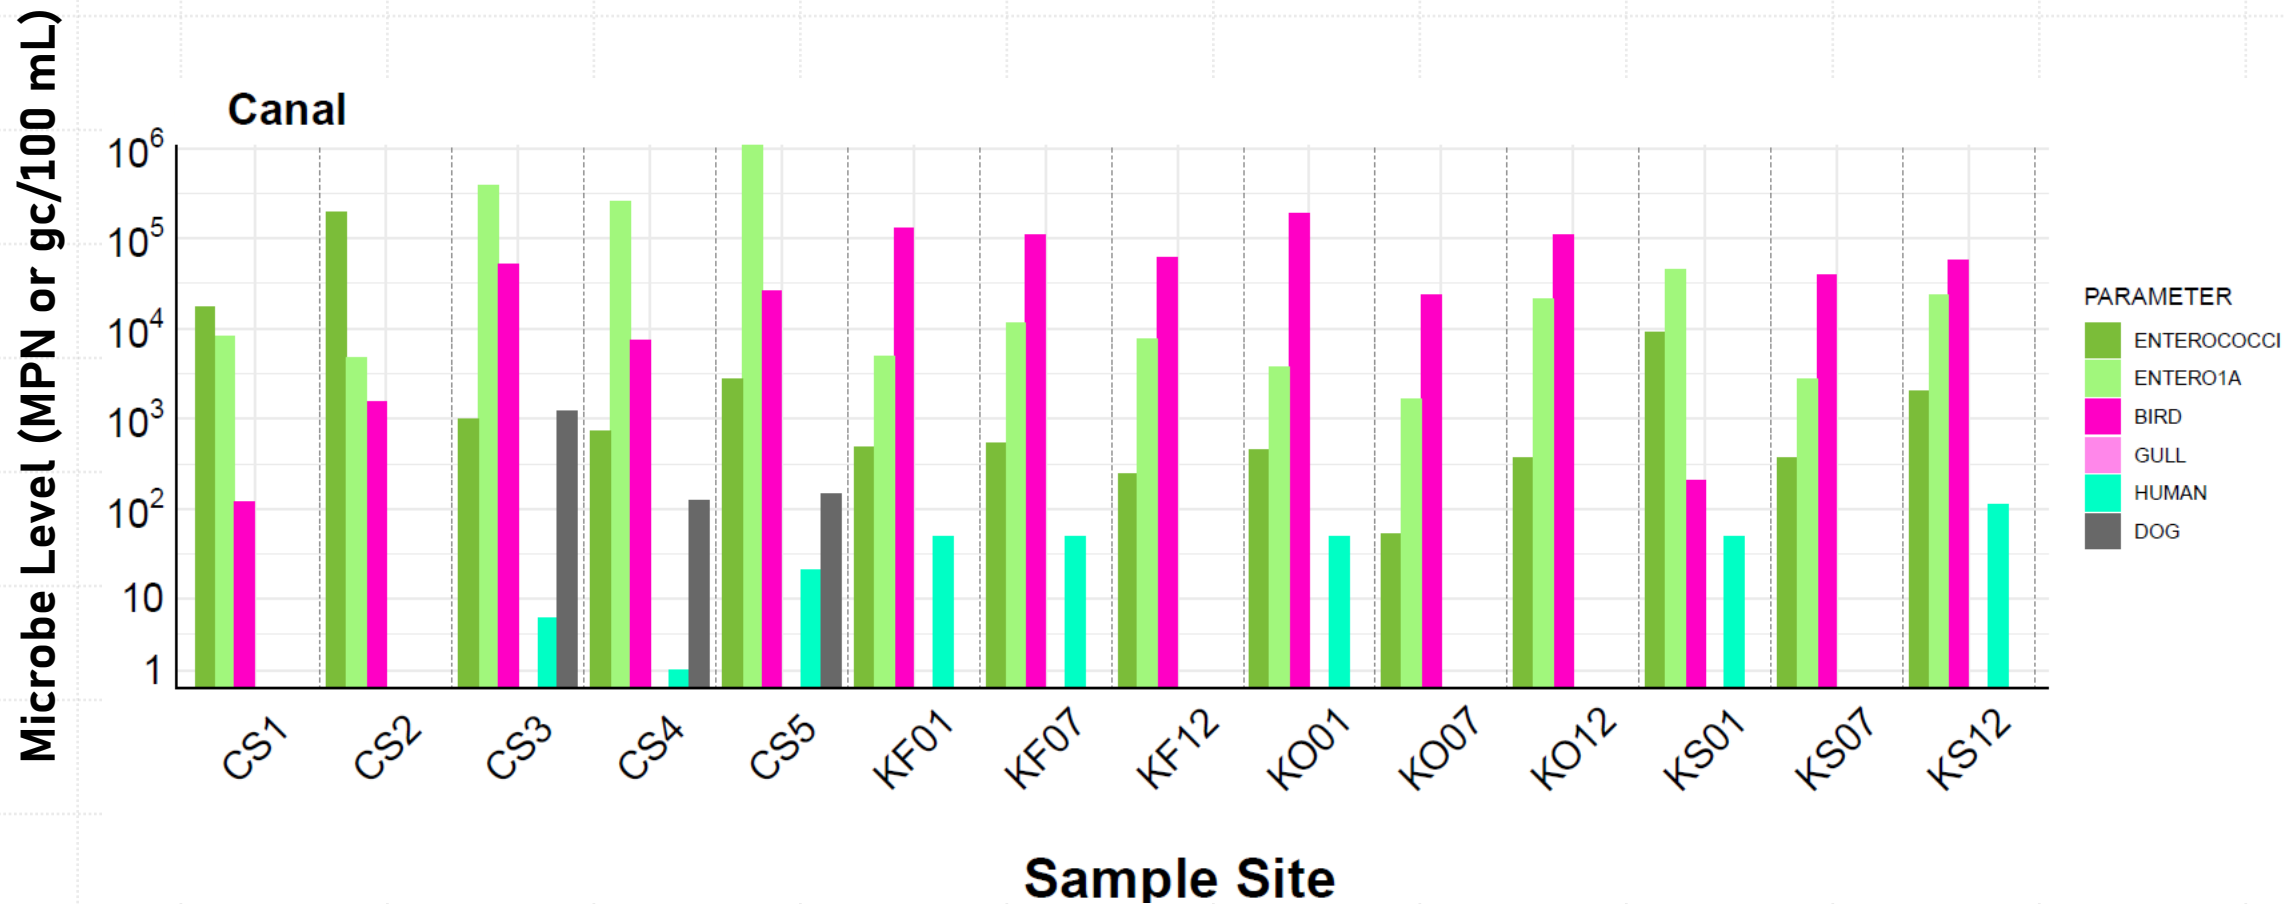
# PVC water shows evidence of bird (a lot), some dog and some human

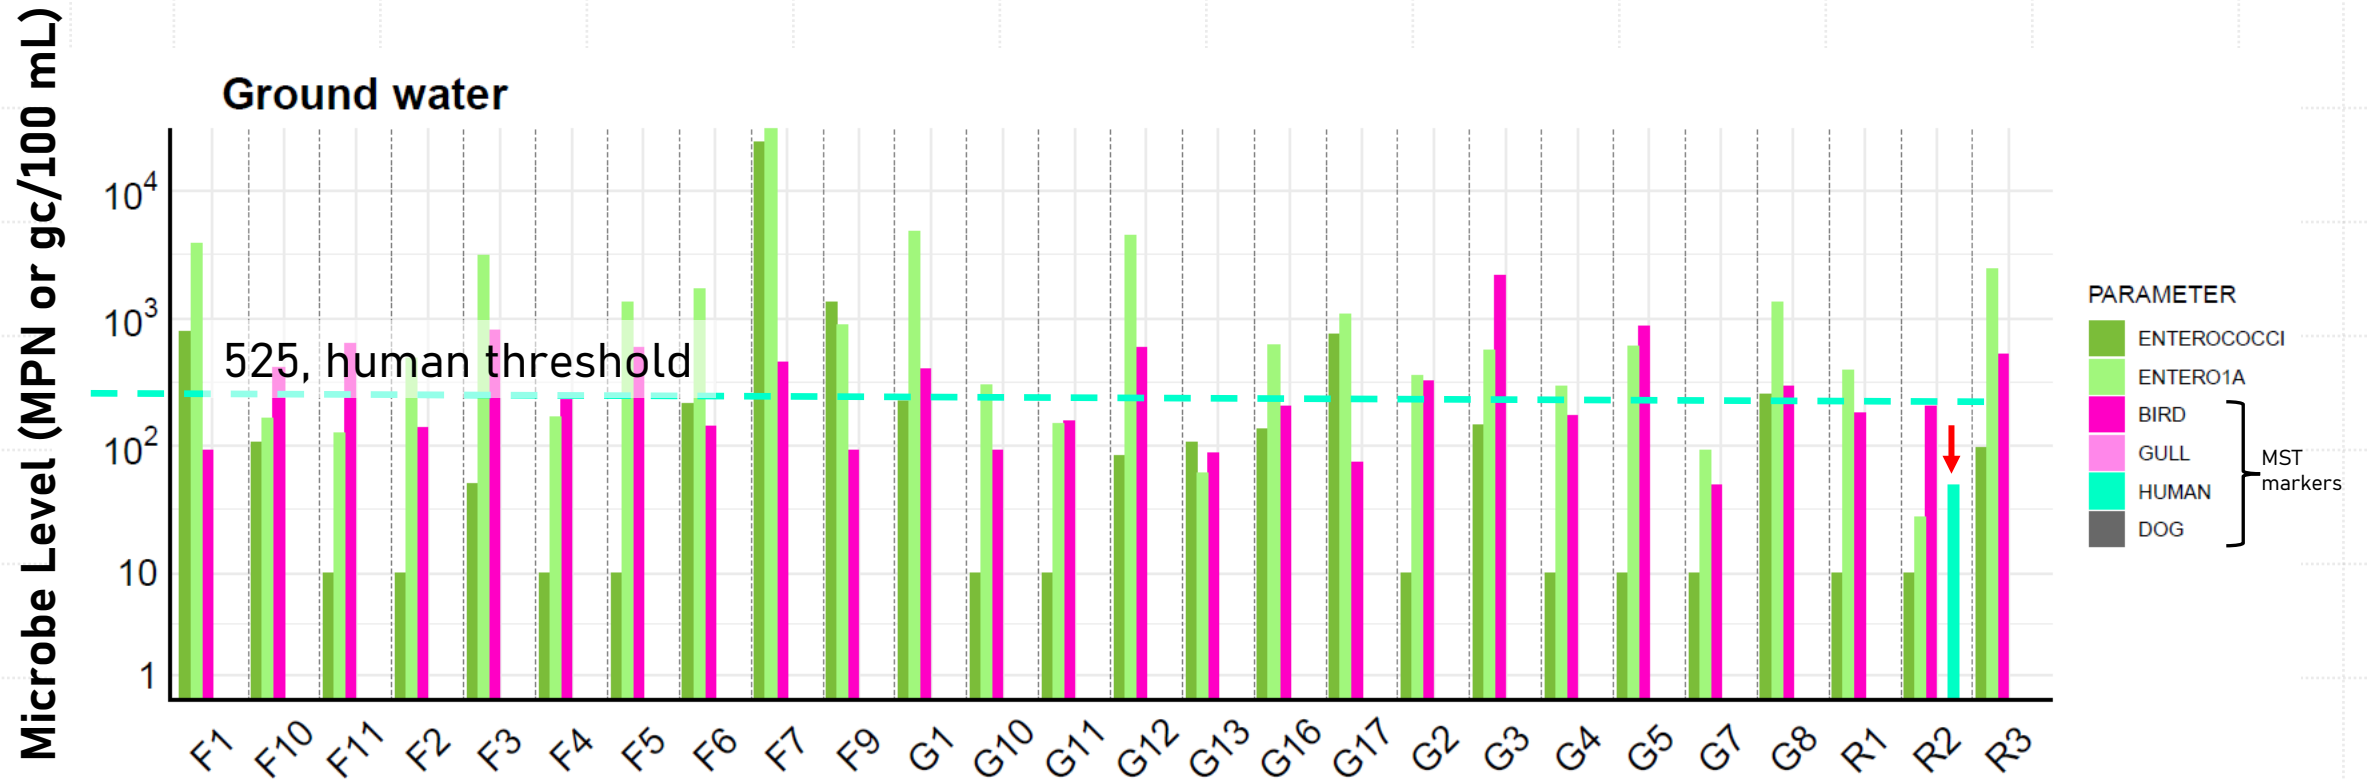
# Groundwater shows evidence of bird (due to stormwater and PVC mixing) but no dog and one with very low human
