**LTC #360-2025**

## LETTER TO COMMISSION

SUBJECT: **UPDATE ON THE IMPLEMENTATION OF "OPERATION CLEAN WATER" PROGRAM - #6**

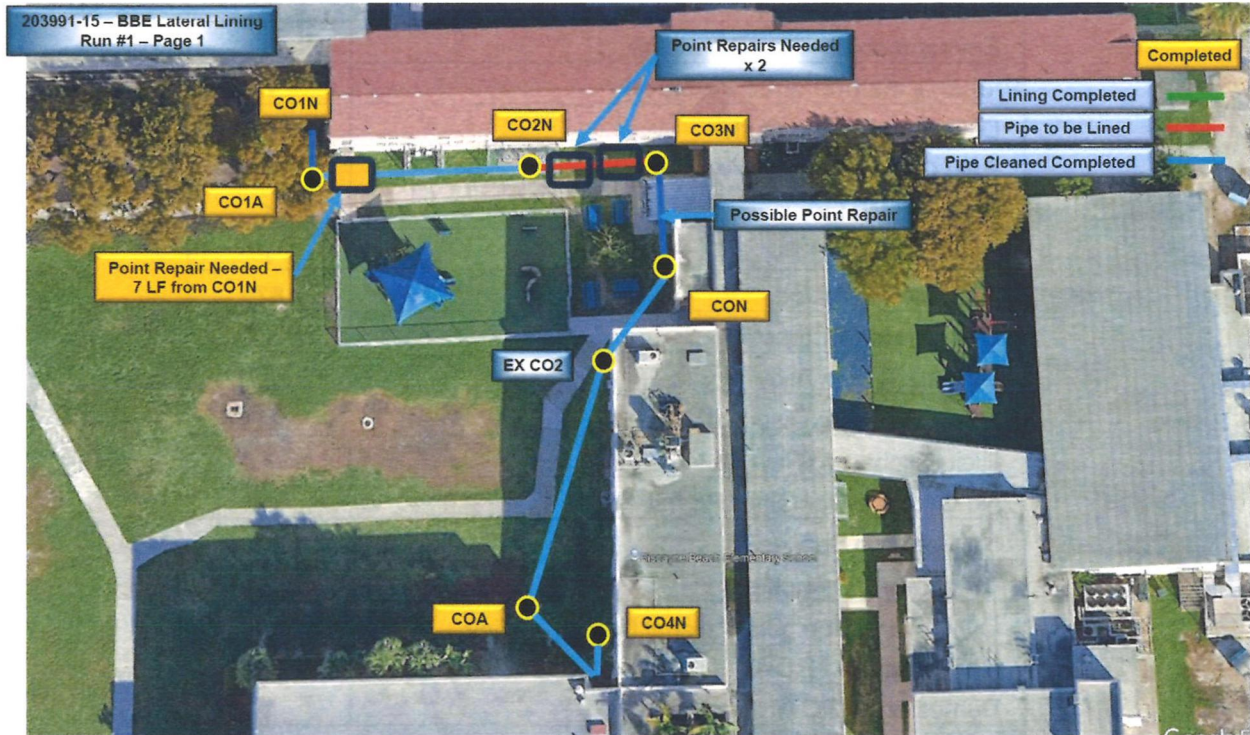
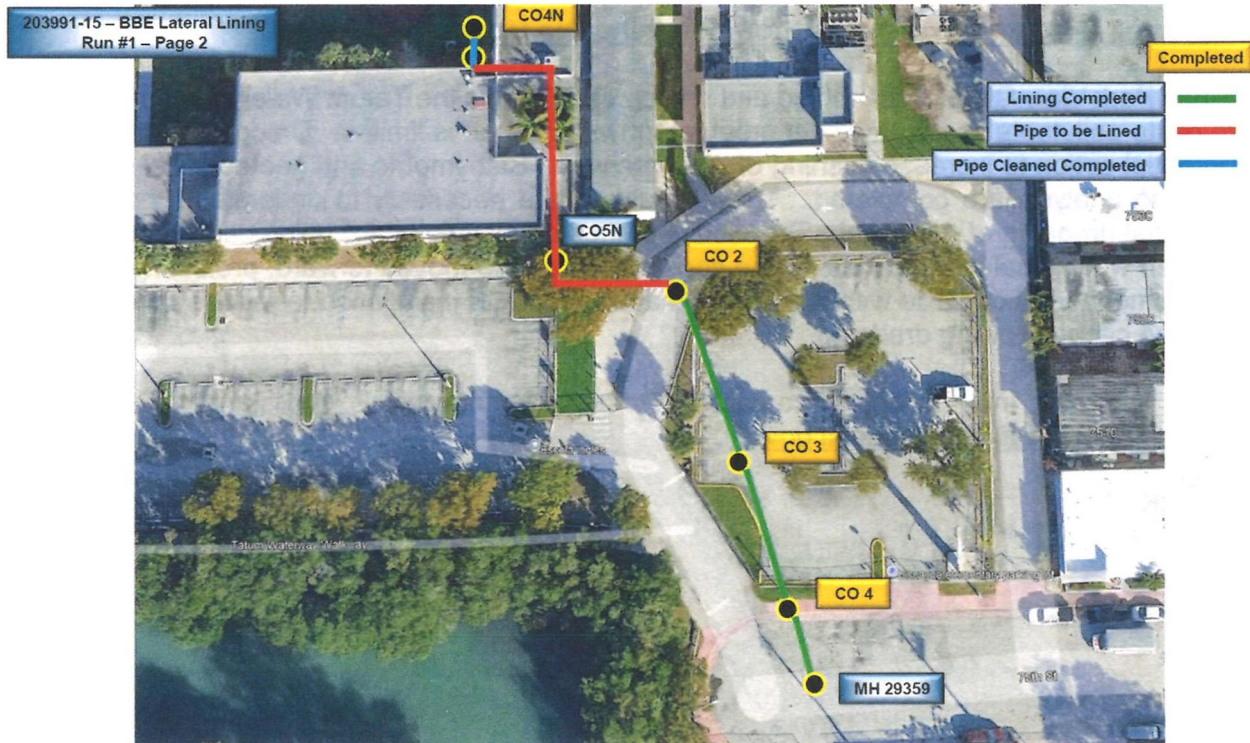
# EXHIBIT - A

Work completed to date includes 1,190 LF of pipe cleaned, 173 LF of pipe lined, 11 cleanouts installed and/or replaced, and 4 point repairs performed. Additionally, 123 LF of pipe will be replaced just outside of the former science rooms, and at the school's request, cleanout 1B (CO1B) in their courtyard will be plugged off.

The attached *updated* maps, 'EXHIBIT – A' provides a graphical update on the scope of work completed to date, and what is anticipated to be completed in the following weeks.
