**LTC #403-2025**

SUBJECT: **UPDATE ON THE IMPLEMENTATION OF "OPERATION CLEAN WATER" PROGRAM - #8**

## **Biscayne Beach Elementary**

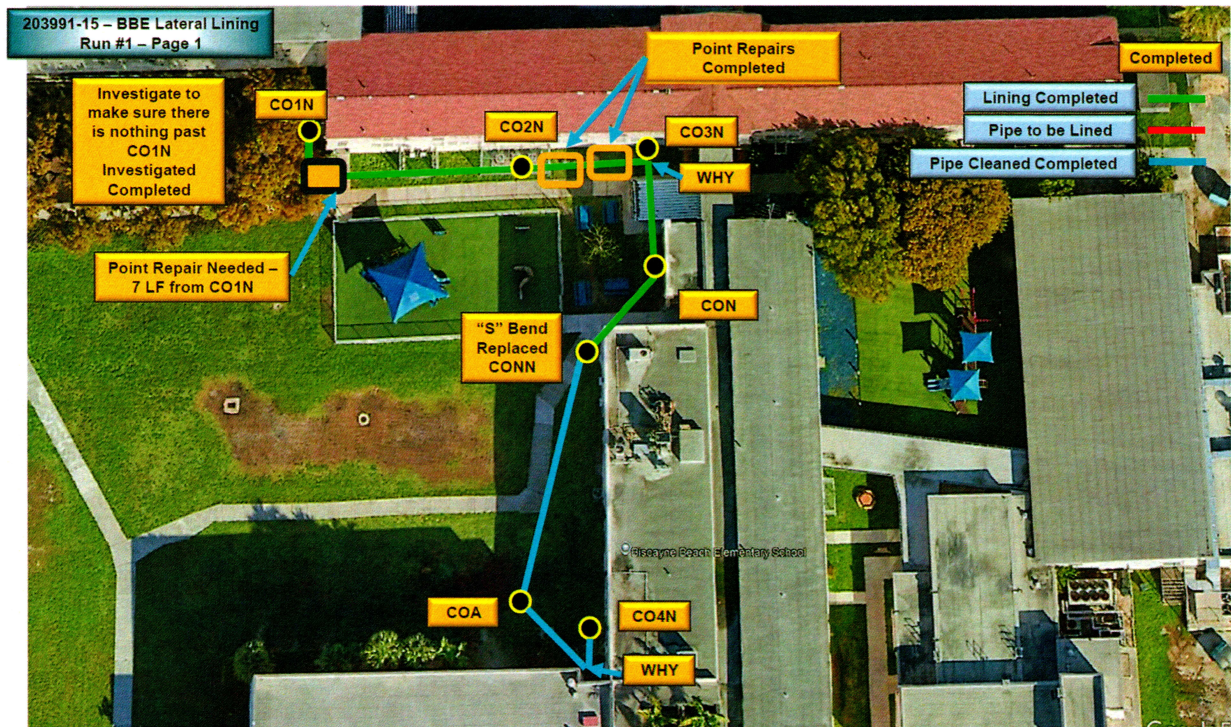
## **EXHIBIT - A**

The attached *updated* maps, 'EXHIBIT – A' provides a graphical update on the scope of work completed to date, and what is anticipated to be completed in the following weeks. All the pipes shown in red and light blue in the map are pending to be lined.

Work completed to date includes: 1,320 LF of pipe cleaned, 204 LF of piping lined, 12 cleanouts installed and/or replaced, and 5 point-repairs performed due to collapsed pipes, rebar obstruction, and cleanout complications. Additionally, the cleanout 1B (CO1B) in the School's courtyard was plugged off.
