LTC #418-2025

LETTER TO COMMISSION

SUBJECT: **UPDATE ON THE IMPLEMENTATION OF "OPERATION CLEAN WATER" PROGRAM - #9**

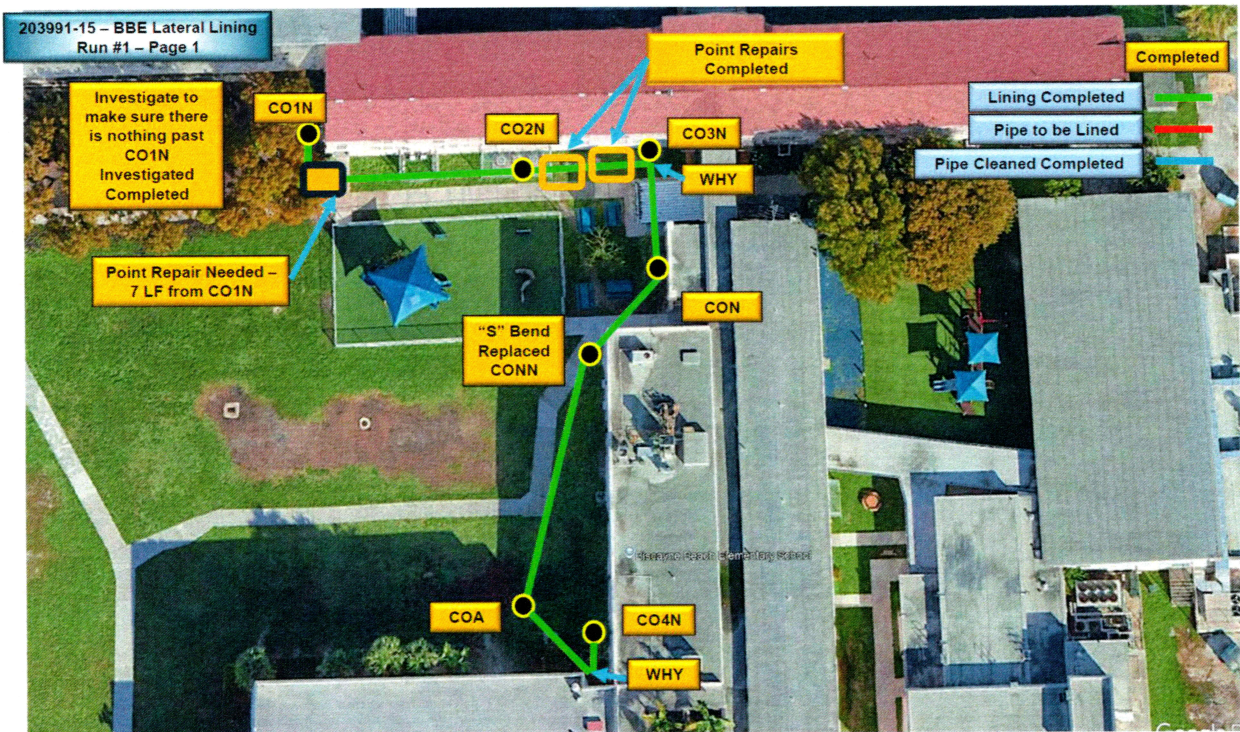
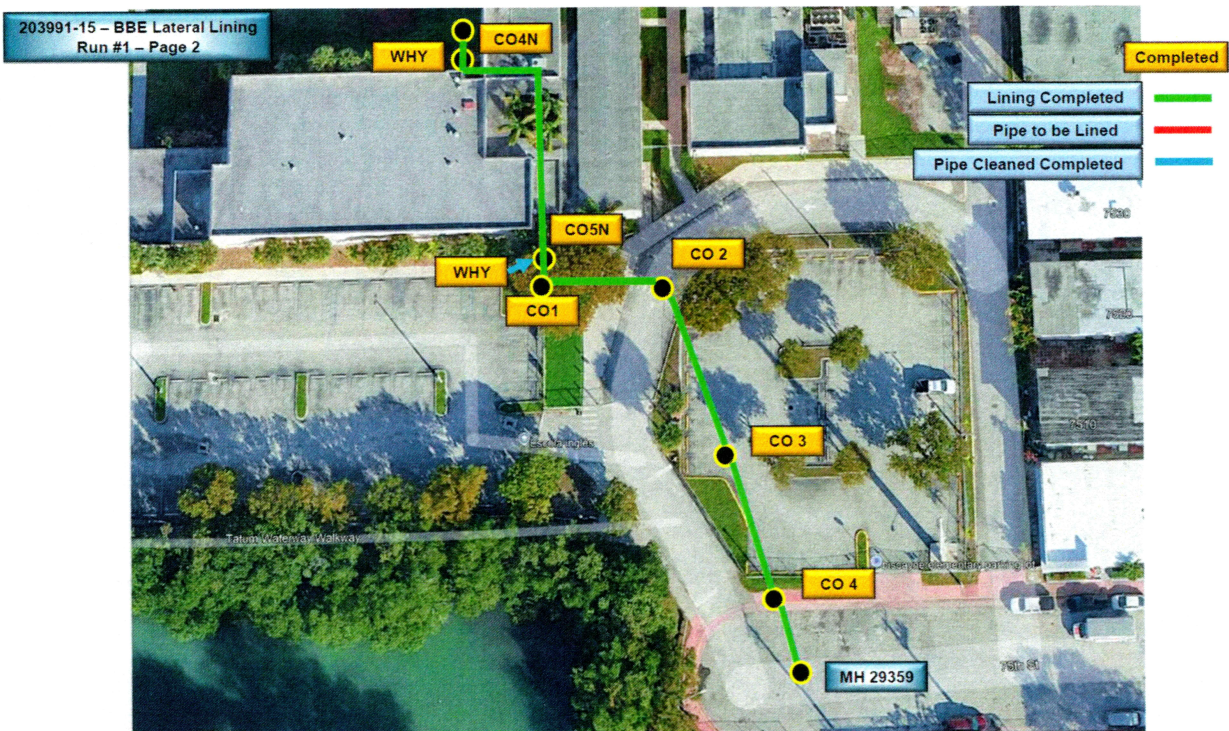
EXHIBIT - A

At this point, Vortex's full scope of work at Biscayne Beach Elementary has been completed. The completed work includes: 1,320 LF of pipe cleaned, approximately 1100 LF of piping lined, 12 cleanouts installed and/or replaced, and 5 point-repairs performed due to collapsed pipes, rebar obstruction, and cleanout complications. Additionally, the cleanout 1B (CO1B) in the School's courtyard was plugged off.

The attached *updated* maps, 'EXHIBIT – A' provides a graphical depiction of the scope of work completed.
