LTC #456-2025

LETTER TO COMMISSION

UPDATE ON THE IMPLEMENTATION OF "OPERATION CLEAN WATER"

PROGRAM - #10

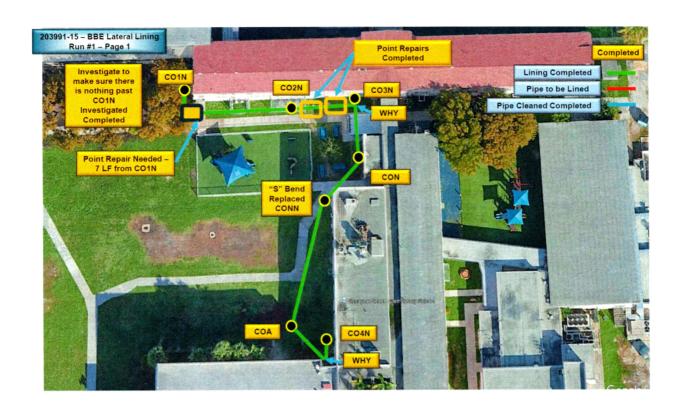
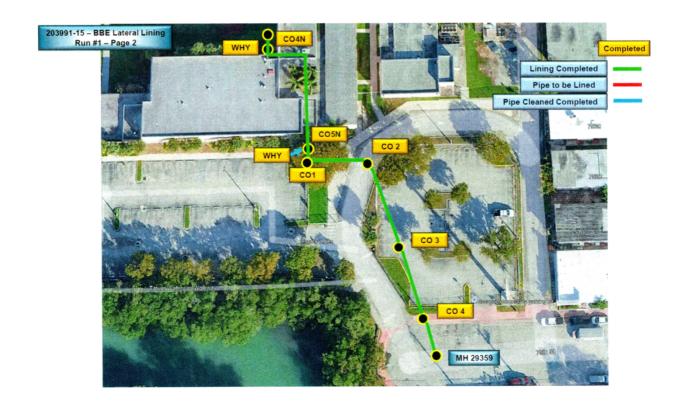
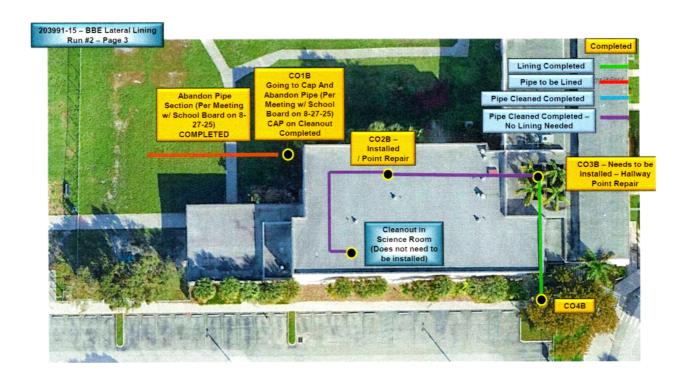
EXHIBIT - A

The attached *updated* maps, 'EXHIBIT – A' provides a graphical depiction of the scope of work completed.

At this point, Vortex's full scope of work at Biscayne Beach Elementary has been completed. The completed work includes: 1,320 LF of pipe cleaned, approximately 1100 LF of piping lined, 12 cleanouts installed and/or replaced, and 5 point-repairs performed due to collapsed pipes, rebar obstruction, and cleanout complications. Additionally, the cleanout 1B (CO1B) in the School's courtyard was plugged off.
