# MIAMI BEACH

**LTC #482-2025**

**LETTER TO COMMISSION**

SUBJECT: **UPDATE ON THE IMPLEMENTATION OF "OPERATION CLEAN WATER" PROGRAM - #11**

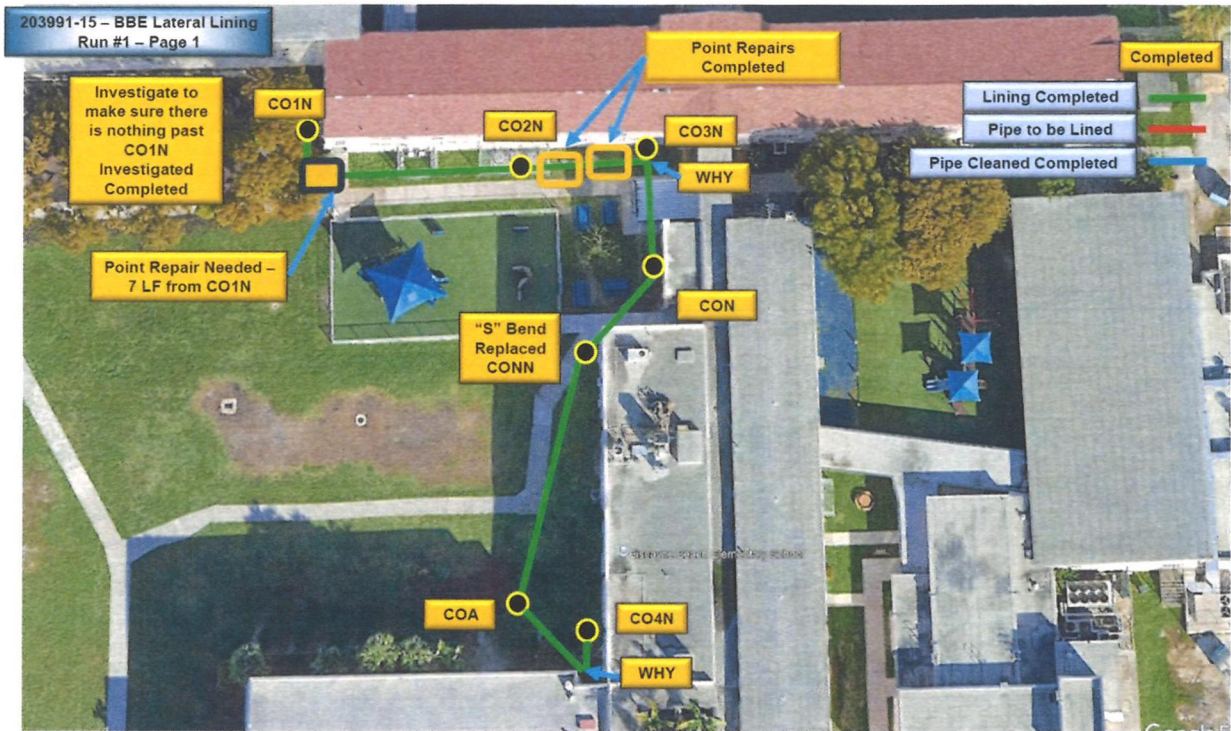
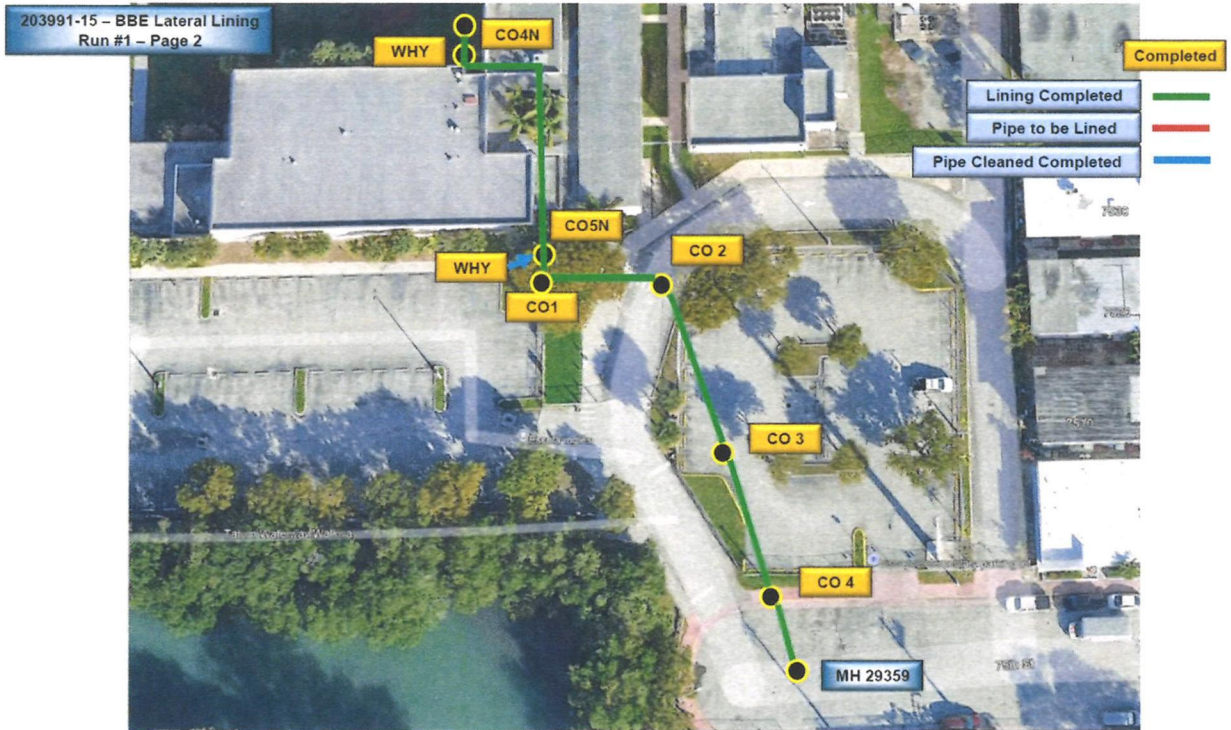
# EXHIBIT - A

At this point, Vortex's full scope of work at Biscayne Beach Elementary has been completed. The completed work includes: 1,320 LF of pipe cleaned, approximately 1100 LF of piping lined, 12 cleanouts installed and/or replaced, and 5 point-repairs performed due to collapsed pipes, rebar obstruction, and cleanout complications. Additionally, the cleanout 1B (CO1B) in the School's courtyard was plugged off.

The attached *updated* maps, 'EXHIBIT – A' provides a graphical depiction of the scope of work completed.
