MIAMI BEACH

LTC # 541-2025

SUBJECT: **UPDATE ON THE IMPLEMENTATION OF “OPERATION CLEAN WATER” PROGRAM - #13**

The purpose of this Letter to Commission (LTC) is to provide the Mayor and City Commission an update on “Operation Clean Water,” adopted on March 19, 2025, by Resolution No. 2025-33559.

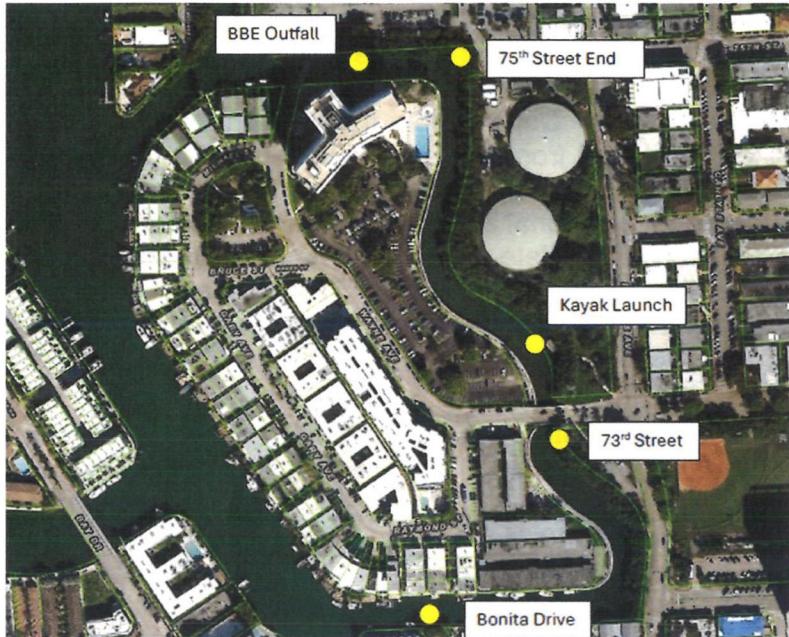
At the September 17, 2025 City Commission meeting, a motion was passed to move forward with and authorize funding for weekly water testing at up to five locations within Park View Canal. At the September 30, 2025 City Commission Budget Meeting, \$21,000 was approved and added to the Public Works' Stormwater budget for FY26 to fund the sampling effort. The Environment and Sustainability and Public Works Departments obtained a proposal and executed a Purchase Order for the Miami-Dade County sampling contractor, Eurofins Environment Testing, on November 14,

2025, and the weekly sampling began on Thursday, November 20, 2025. Eurofins Environment Testing is a certified laboratory utilized by the Miami-Dade County Surface Water Quality Monitoring Program for water quality sampling. The sampling map was developed by the Environment and Sustainability Department, drawing on known hotspot locations, publicly accessible shorelines, and input from Dr. Helena Solo-Gabriele, Associate Dean, University of Miami College of Engineering. There may be an opportunity to adjust sampling points at a later date to include sampling for additional areas and to collect unique data points. Sampling results (CMB Results) for enterococci to date are as follows, and the table also includes a column for Surfrider Foundation's Miami Chapter Blue Water Task Force (BWTF) results for water samples they collect at the Park View Canal kayak launch as requested by the City Commission:

The sampling map is as follows:

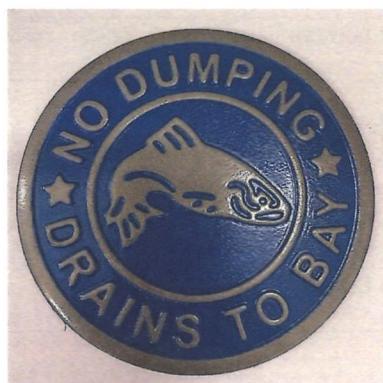
Stormwater drain markers were ordered and are being placed throughout Parkview Island and Parkview extended area (72nd Street – 76th Street) at stormwater inlets. Installation of the drain markers will be completed before the end of December 2025. Below is a sample of the markers:

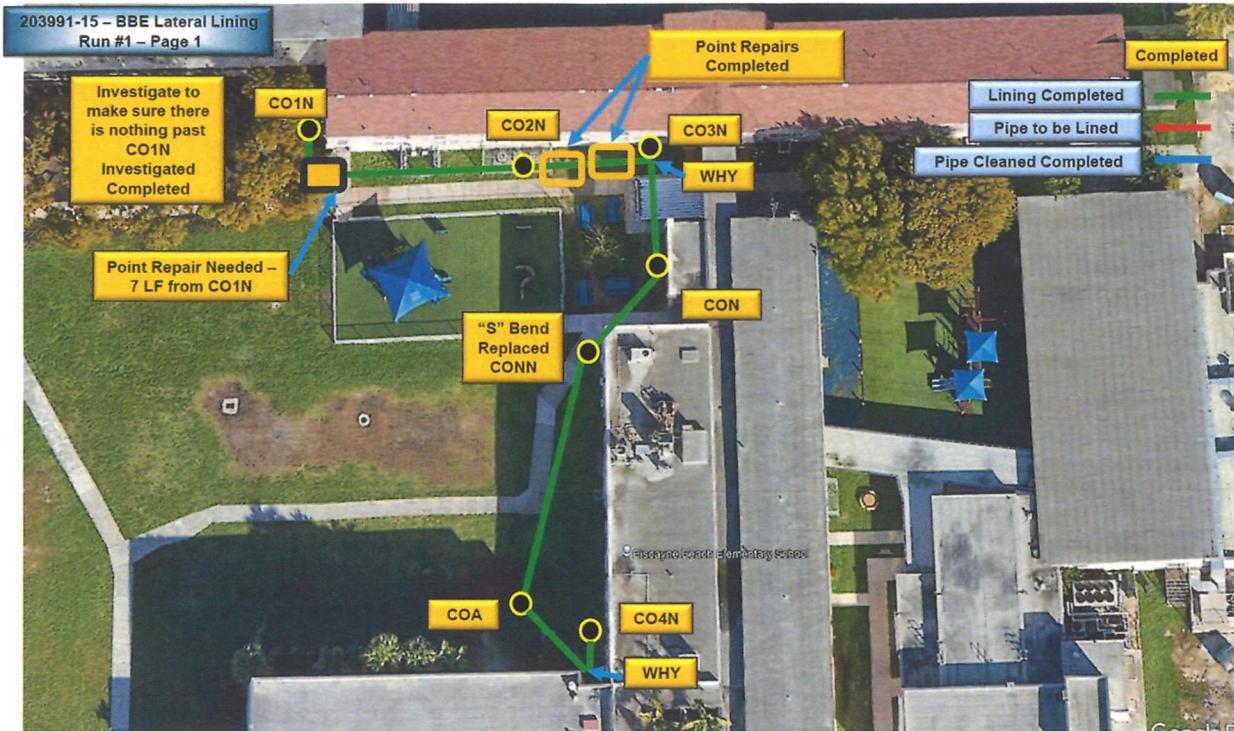
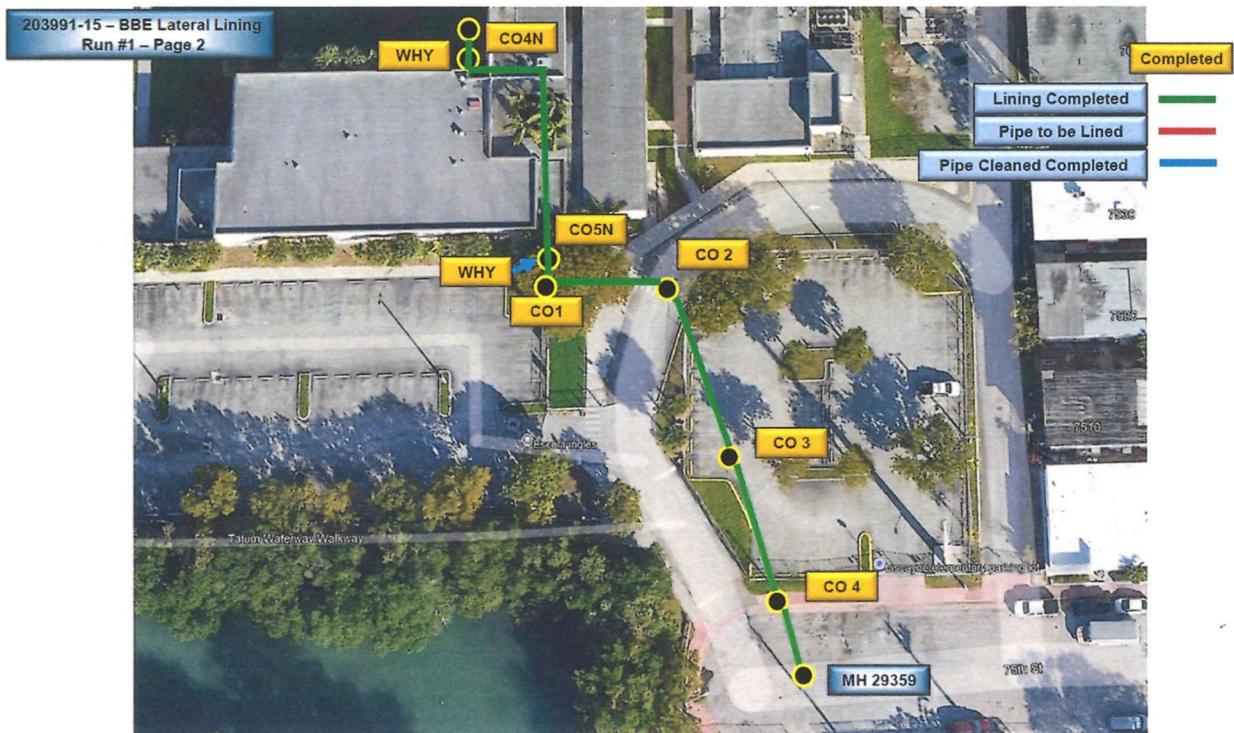
EXHIBIT - A

At this point, Vortex's full scope of work at Biscayne Beach Elementary has been completed. The completed work includes: 1,320 LF of pipe cleaned, approximately 1100 LF of piping lined, 12 cleanouts installed and/or replaced, and 5 point-repairs performed due to collapsed pipes, rebar obstruction, and cleanout complications. Additionally, the cleanout 1B (CO1B) in the School's courtyard was plugged off.

The attached *updated* maps, 'EXHIBIT – A' provides a graphical depiction of the scope of work completed.
